## Lab I

### Accessible Pedestrian Infrastructure Deficiencies: Woodburn Village Condominiums

7 November 2022

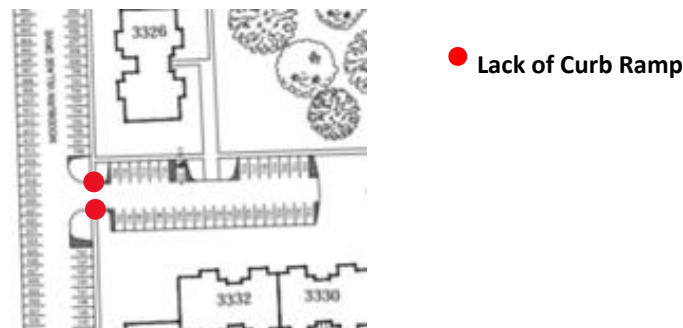
The most common issue, Lack of Curb Ramp, was observed along most sidewalk crossings at intersections with vehicle access to dead end parking sections (Figure 3.) as well as various points where sidewalks approached and were adjacent to curbs along parking spaces.

**Figure 3.** Example of Lack of Curb Ramps at parking lot intersections.

The most frequent issue observed, Lack of Curb Ramp, is of particular concern. Although no wheelchair individuals have been observed (that is not to say none live within the community), as mentioned previously, several elderly individuals live within the community. A few of these elderly individuals have been observed to utilize walking aids such as walkers and are frequently actively mobile on their own either for recreational exercise or to access other modes of transportation (their vehicle or public transit). One such individual has been observed to traverse along the throughway of the parking lots around the complex instead of utilizing adjacent sidewalks, presumably due to the lack of curb ramps in addition to a lack of sidewalk ramps in certain areas where only stairs exist. This is concerning for these individual's safety and wellbeing within their own residential community.

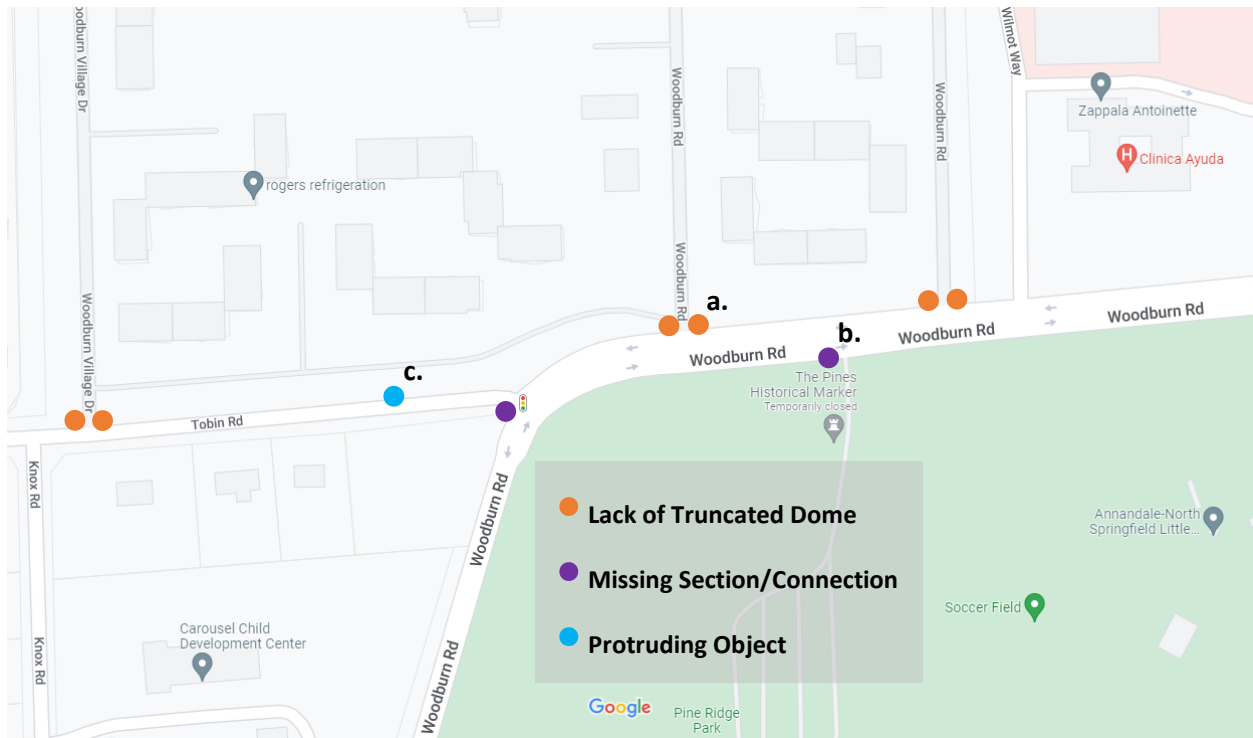
In addition to issues observed on the private sidewalks within Woodburn Village, notable issues were observed on the public right of way along Woodburn Rd and Tobin Rd. Such issues included Lack of Truncated Domes on all sidewalk crossings with access intersections to the Woodburn Village property, two Missing Section/Connections where sidewalks crossed the public roads to non-existent sidewalks on the other side of the road opposite of the property where a public park and place of worship exist, as well as a protruding object where an adjacent storm sewer structure was not flush with the sidewalk (Figures 4, 5).

**Figure 4.** Locations of issues along public right of ways Woodburn Rd and Tobin Rd.

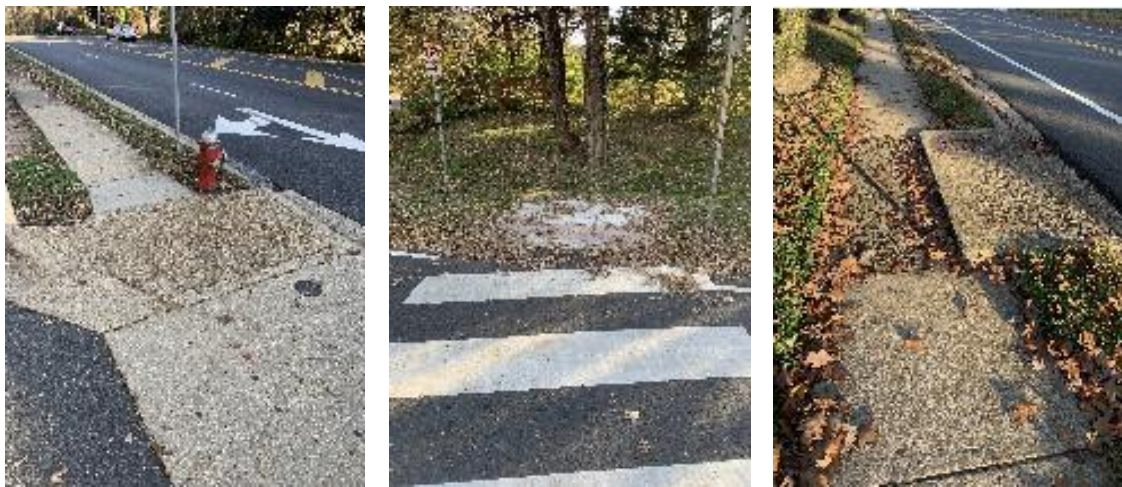
**Figure 5.** Examples of (a.) Lack of Truncated Dome, (b.) Missing Section/Connection, and (c.) Protruding Object along public right of ways Woodburn Rd and Tobin Rd.
